Manhole Inspection Summary

Manhole # S21MM1010MH

Insp Date: **11/9/06 9:32 AM**

Location Address: **4417 FALLS BRIDGE DR**

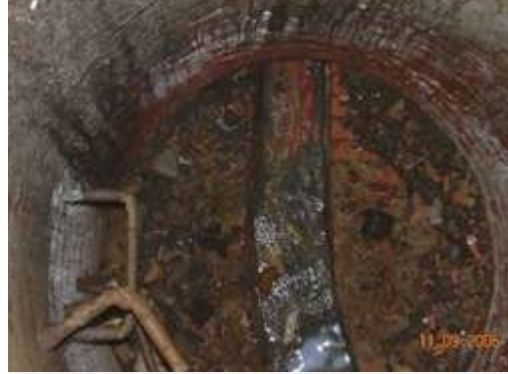
Top View

Steps Count: **4** Missing: **0** ☒ **Corroded**

Surcharge ☒ **Evidence Of Surcharge** Depth: **3** (ft.) ☐ Active Surcharge Present

Corroded steps. Evidence of surcharge - Bench debris. Channel debris.

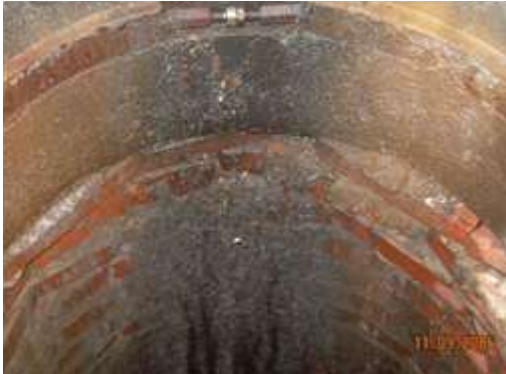
Defect

☒ **Leaks**

Condition: ☐ Sound ☐ Cracked ☐ Root Intrusion ☐ Loose Brick ☒ **Deteriorated**

Infiltration: ☐ None ☒ **Joint** ☐ Cracks ☒ **Mortar** ☐ Roots ☐ Wall

Frame leaks. Adjustment deterioration and infiltration.

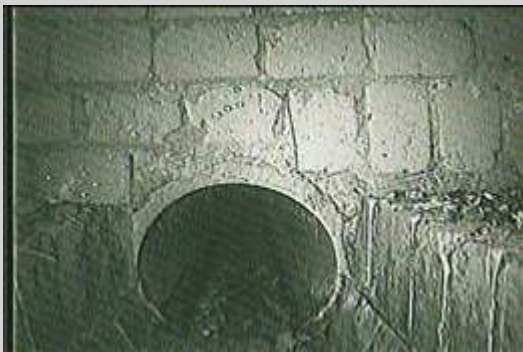
8 in. Circular Gravity Sewer Pipe Out @ 12 O'Clock

Pipe Material: **Clay** ☐ Pipe Lined

Invert Depth: **10.18** (ft.) Flow Characteristics: **Slow**

Infiltration: **None** Pipe Seal Cond: **Unknown**

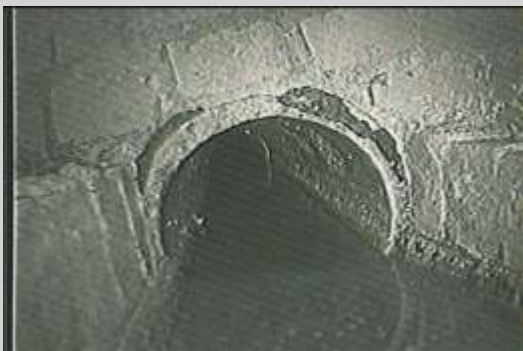
8 in. Circular Gravity Sewer Pipe In @ 5 O'Clock

Pipe Material: **Clay** ☐ Pipe Lined

Invert Depth: **10.00** (ft.) Flow Characteristics: **Slow**

Infiltration: **Evidence** Pipe Seal Cond: **Unknown**
